**City of Waukesha, Wisconsin**

**Phase II Final Report  
Sanitary Sewer System Master Plan**

**City of Waukesha**  
September 2011

**Donohue & Associates, Inc.**

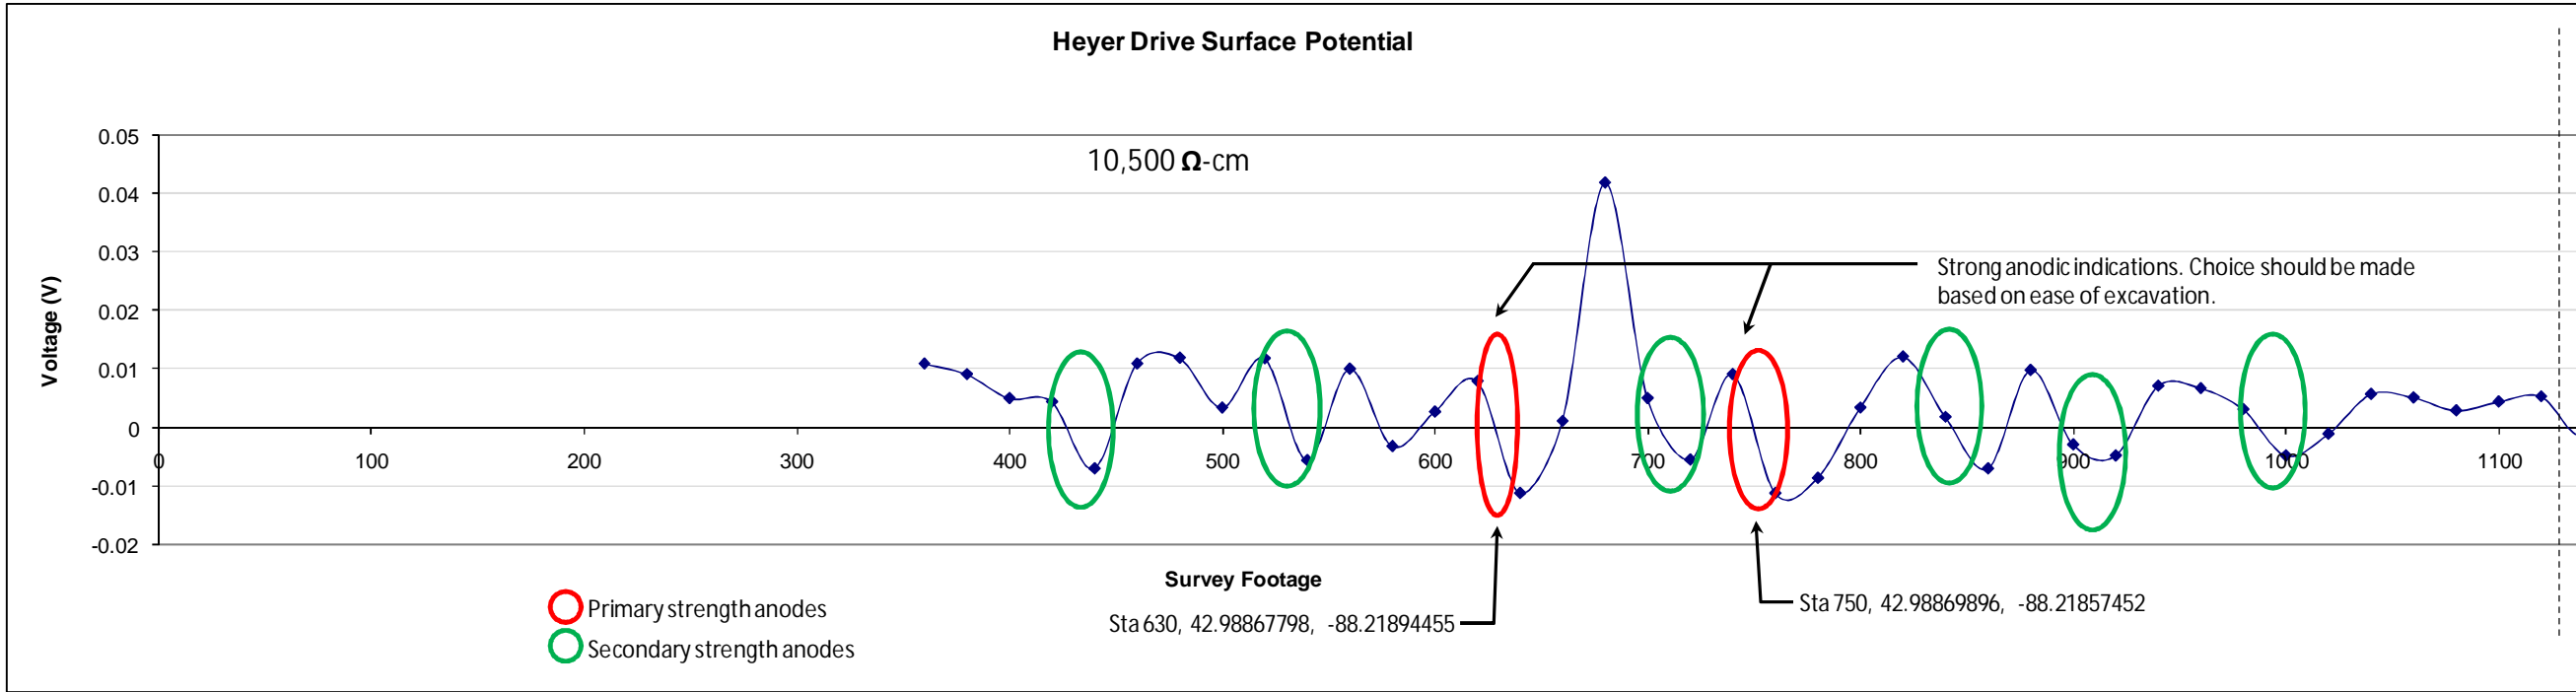
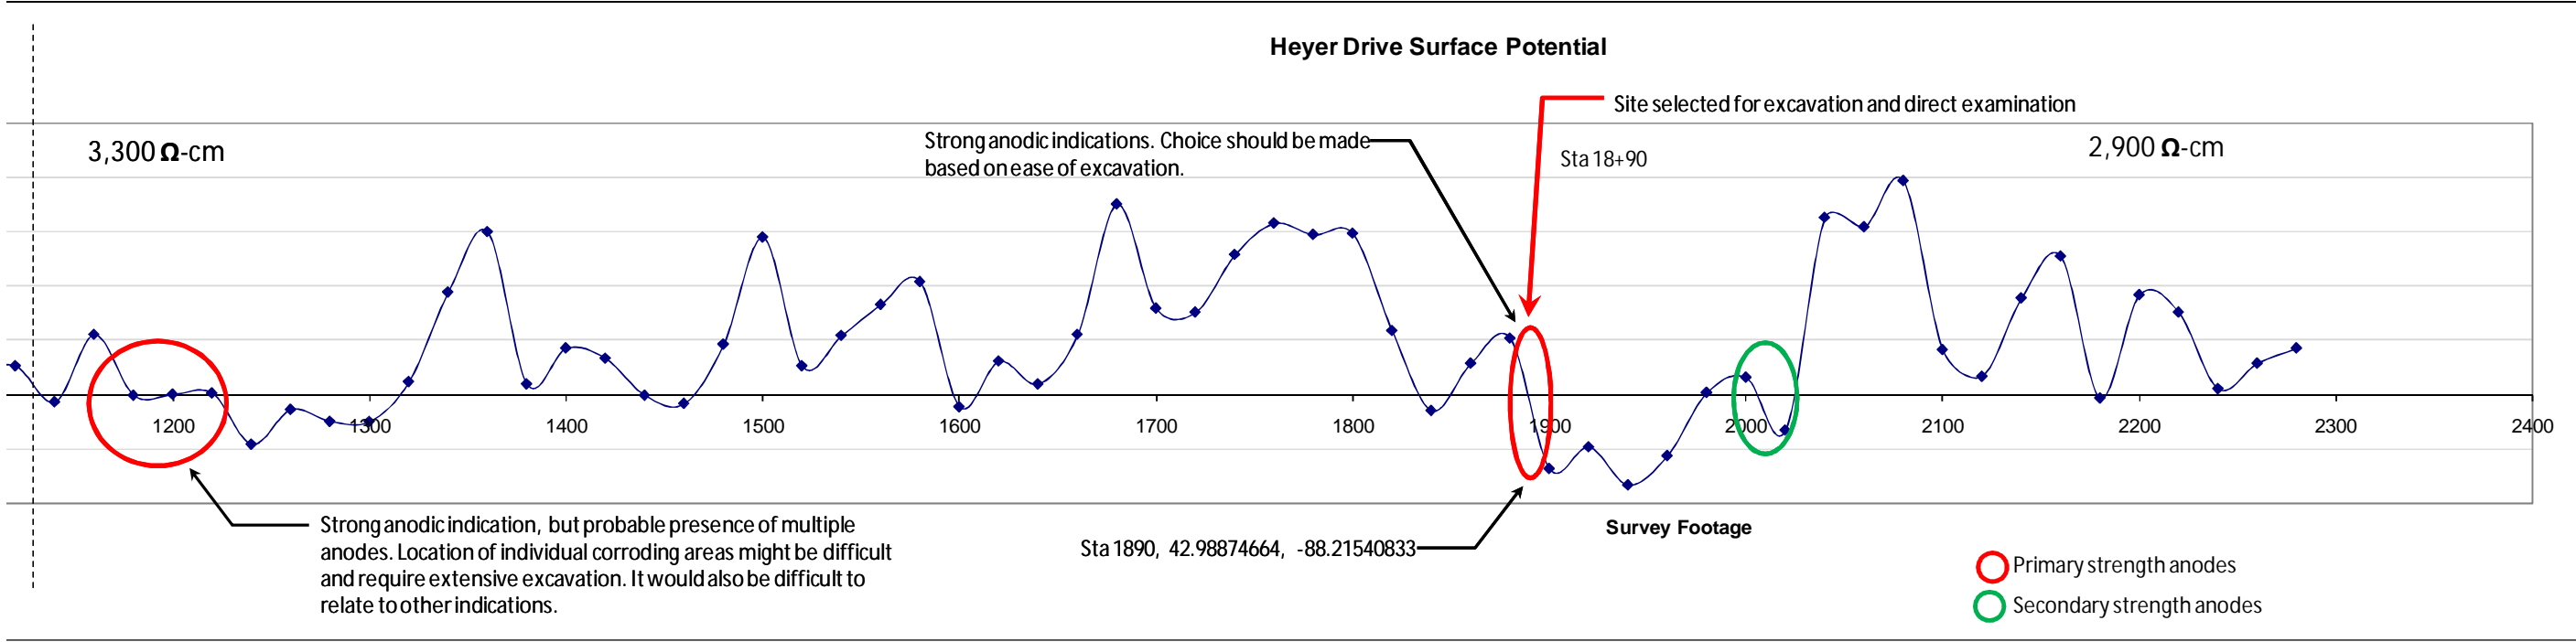
Figure 9 – Heyer Drive Two-Cell Potential Survey

Testing of the Heyer Drive force main was performed from Station 3+60 to Station 22+80, utilizing the two-cell technique. Soil resistivity was measured at three locations, Station 1+60, Station 12+30, and Station 22+30 with readings of 10,500  $\Omega$ -cm, 3,300  $\Omega$ -cm, and 2,900  $\Omega$ -cm respectively. Seventeen anode/cathode pairs are evident (see Figure 9). The majority of these are unexpectedly located on the portion of the force main having higher soil resistivity readings. Eleven of these sites were selected as potential direct examination sites; four as primary sites and the remaining seven as secondary sites.

All seventeen anodic indications were evaluated and compared to the directly examined site (Figure 10). The extrapolation calculations suggest three locations of possible concern with potential pitting as much as fifty percent of the pipe wall thickness. Again it must be remembered that these are extrapolations from a very limited data set and should not be viewed in the same light as actual measured values. The locations of concern are at Stations 7+05, 12+00 and 18+35 (Figure 11) where thinning of the pipe wall is likely at its maximum. These areas are estimated to have pitting rates of 3 to 5 mils/yr. Consistent with the estimated maximum depth of penetration and pipe age, the estimated maximum pitting should be expected to take another forty years for pipe penetration to occur. Leakage would be expected sooner than that as internal pressure exceeds the strength of the remaining material

An anode was installed on the exposed pipeline to protect this pipe stick from corrosion. Waukesha might want to closely monitor the areas identified as having a probability of significant corrosion pitting by re-testing every 5-10 years. Since the observed corrosion has consisted of scattered pitting, the probable mode of failure, should it occur, would likely be a leak of some size rather than a sudden catastrophic failure. If opportunities to expose the force main in these areas present themselves, it should be examined for the presence of corrosion and the condition analysis adjusted to reflect any new measurements.

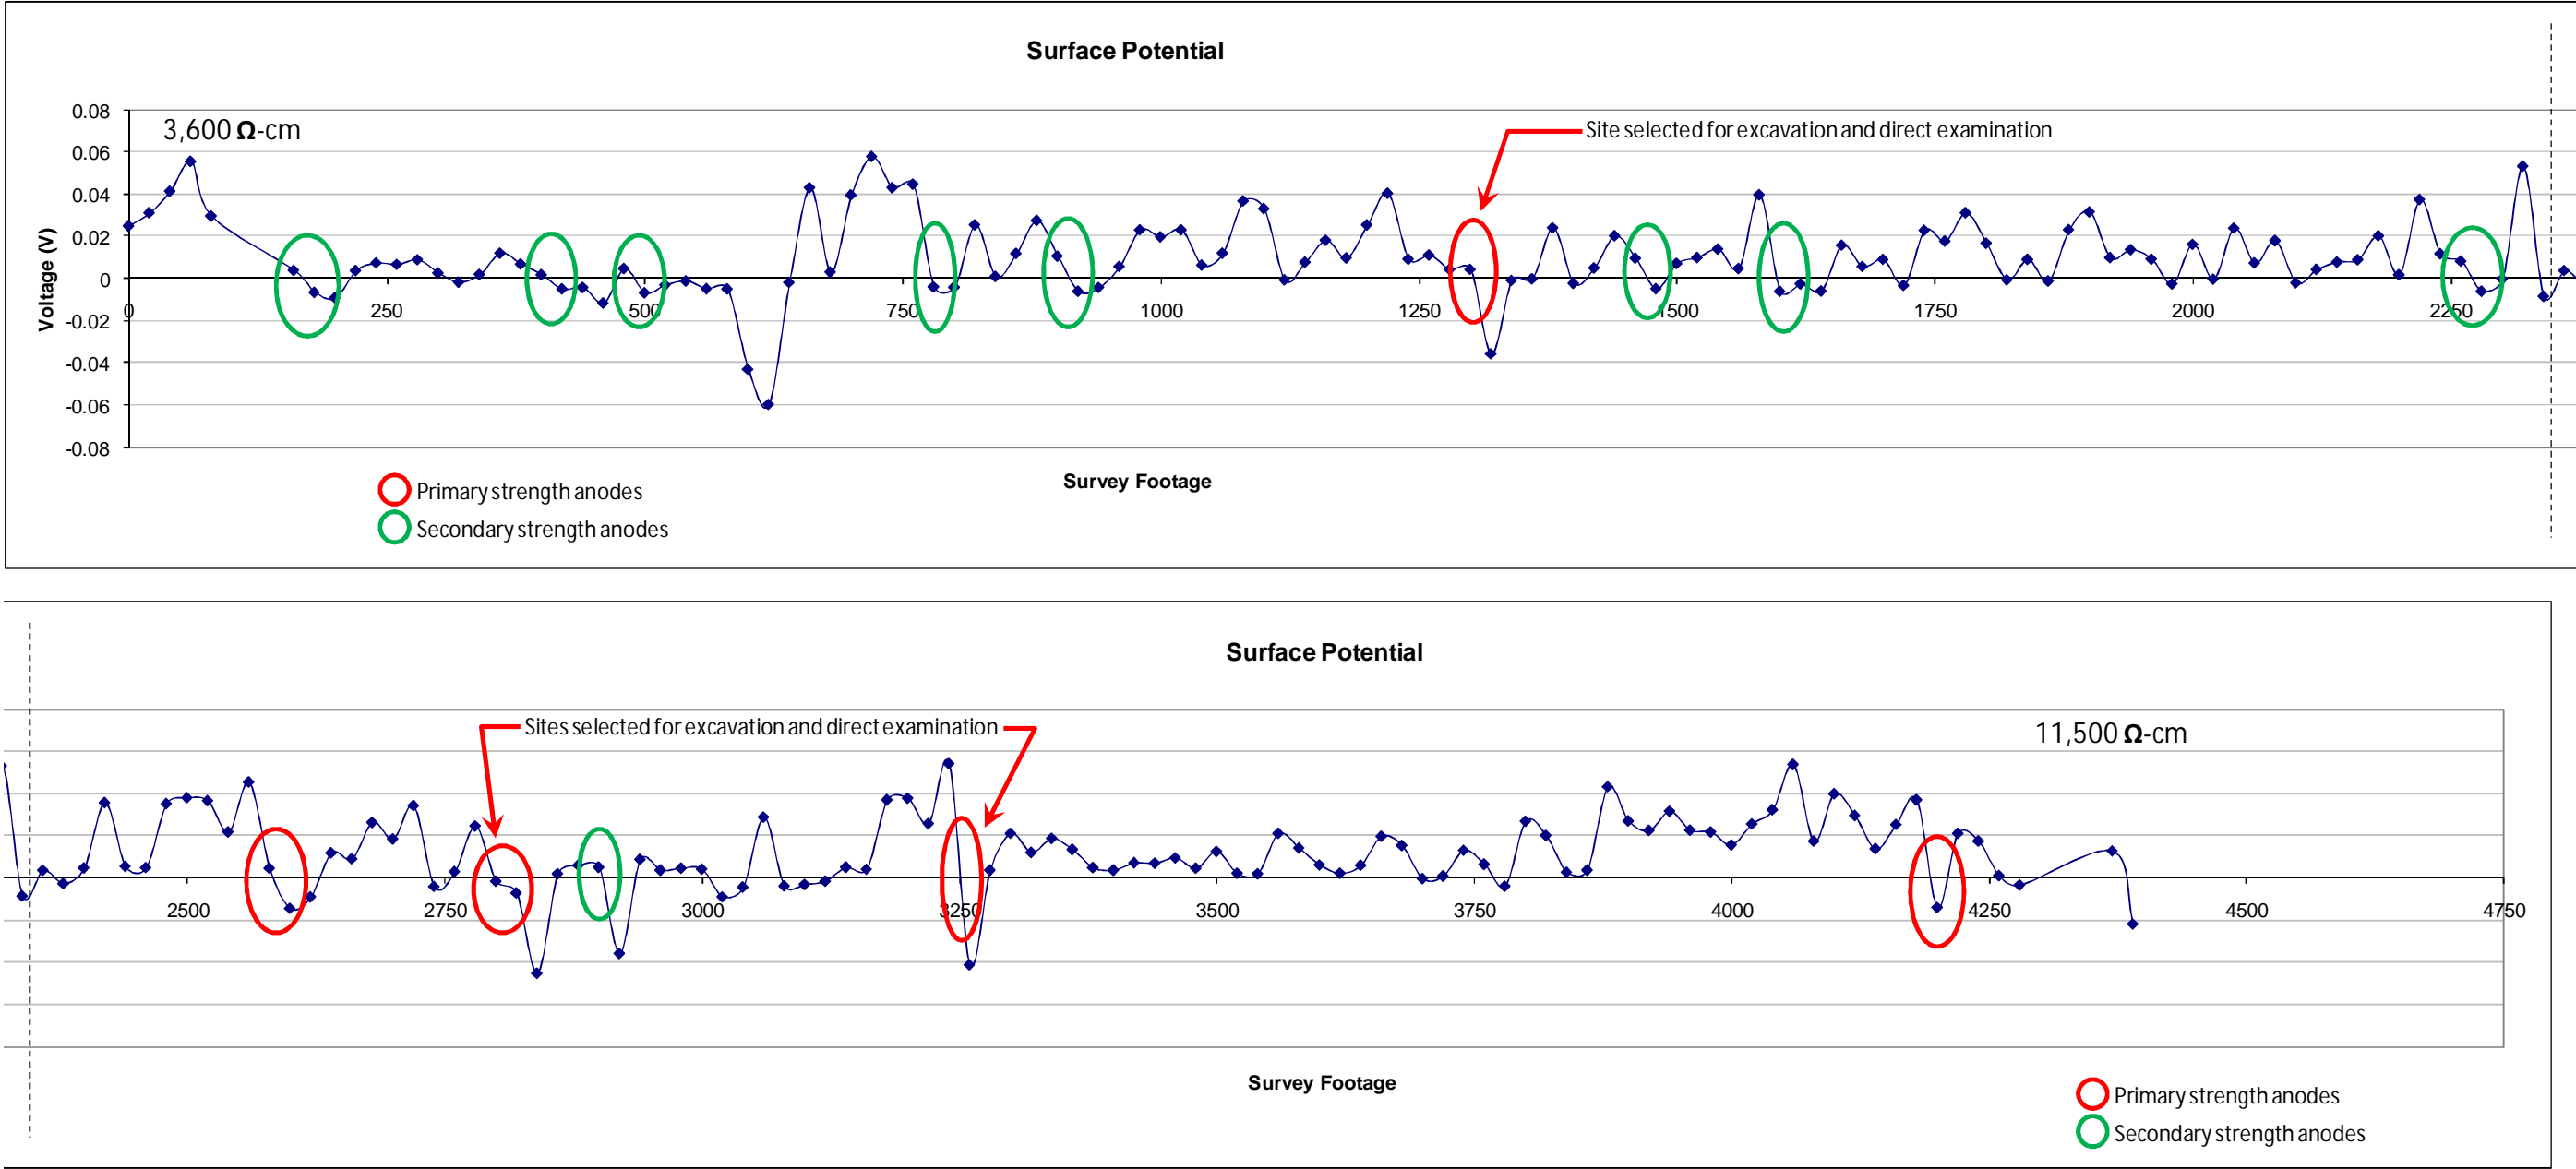
Figure 12 – Pebble Valley Two-Cell Potential Survey

The Pebble Valley force main was tested utilizing the two-cell potential profile technique from Station 0+00 to Station 43+60 (Figure 12). Soil resistivity was measured at each end of the force main, at Stations 1+30 and 41+35, with resistance of 3600  $\Omega$ -cm and 11500  $\Omega$ -cm respectively. Two-cell potential measurements ranged between -0.0597V and +0.0578V and thirty-one anode/cathode pairs were noted on the Two-cell Potential Profile. Fourteen sites were selected as candidates for direct examination with five primary sites and ten secondary sites.

Figure 13 graphically depicts an evaluation of the thirty-one anodic indications. Although there were numerous indications on this force main, they do not appear to be severe. In only one case does the estimated pitting rate exceed 2 mils/yr., and at only five locations does the estimated maximum pitting depth exceed ten percent of the pipe wall thickness. The evaluation does not indicate any areas of concern on this force main.

Galvanic anodes were installed at each excavation location. These should provide local protection from corrosion. Of particular concern is the situation at Station 13+00. This emphasizes the importance of preventing contact between crossing pipes during construction.

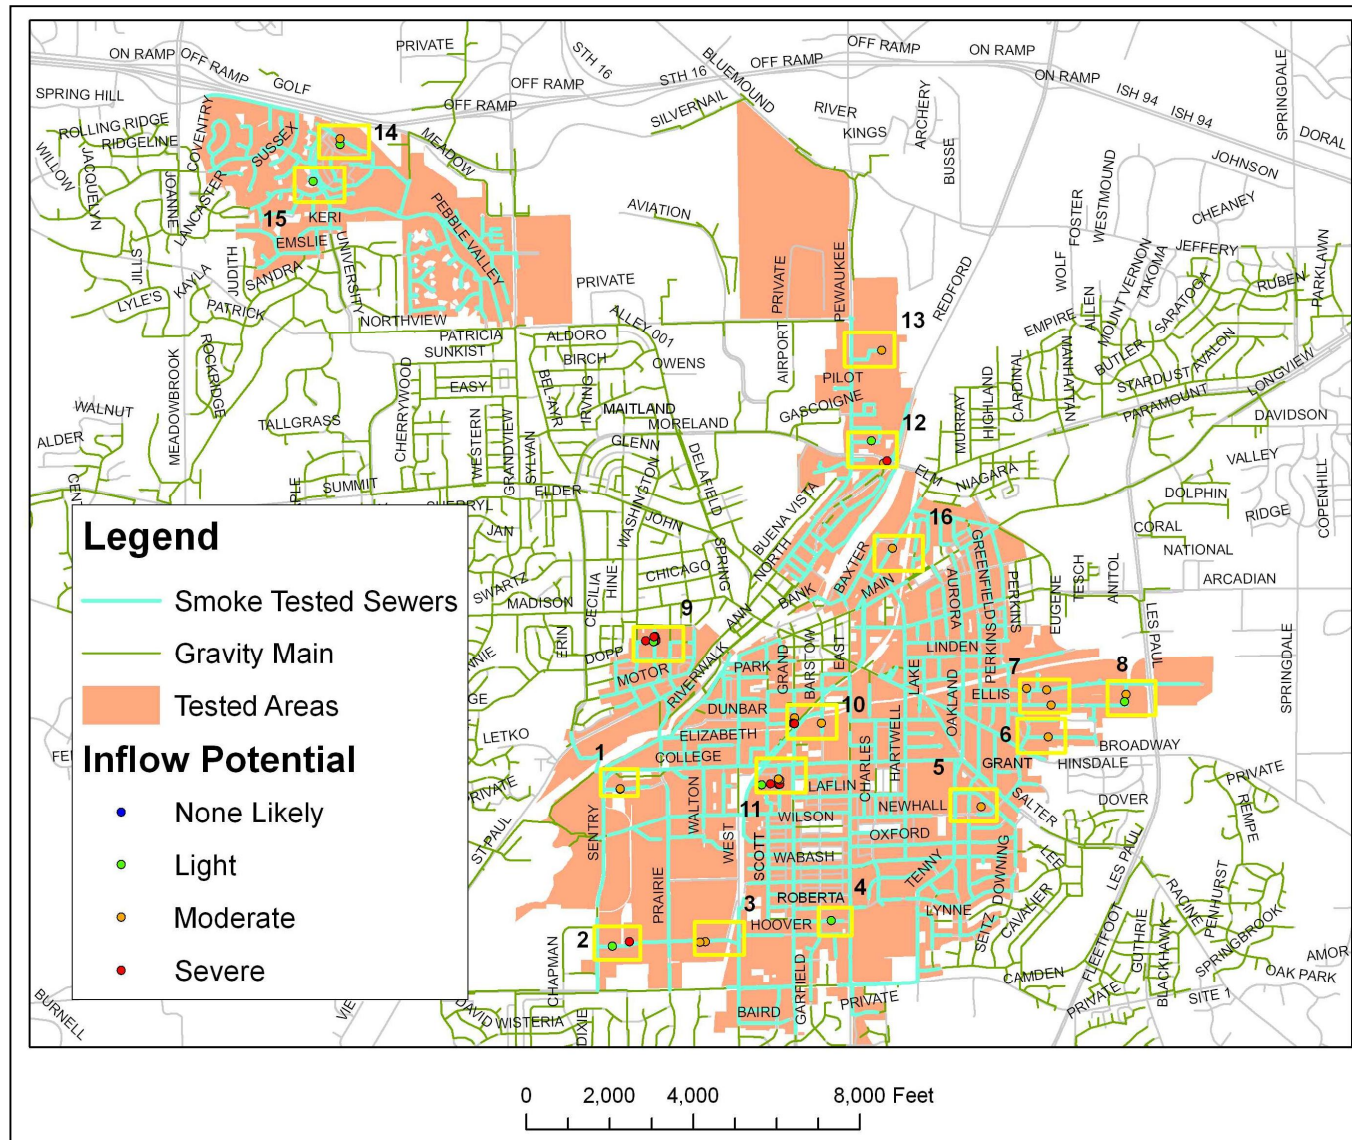
Figure 15 – Smoke Testing Areas

In total, approximately 66 miles of sewers (25% of all sewers owned by the City) were tested over the two-year period and a total of 41 defects (see Table 2) were found, an average of only one defect every 1.5 miles of sewer (see Figure 15). This relatively low value indicates that there are likely few locations where stormwater can directly enter the sanitary sewer system.

Many of the located defects were simply broken or missing clean-out caps. We recommend these be replaced. Smoke testing also revealed several system defects that warrant further inspection / testing. These defects, numbered according to the Object ID in the GIS, are discussed in Table 2, along with recommendations for further investigation / repairs.

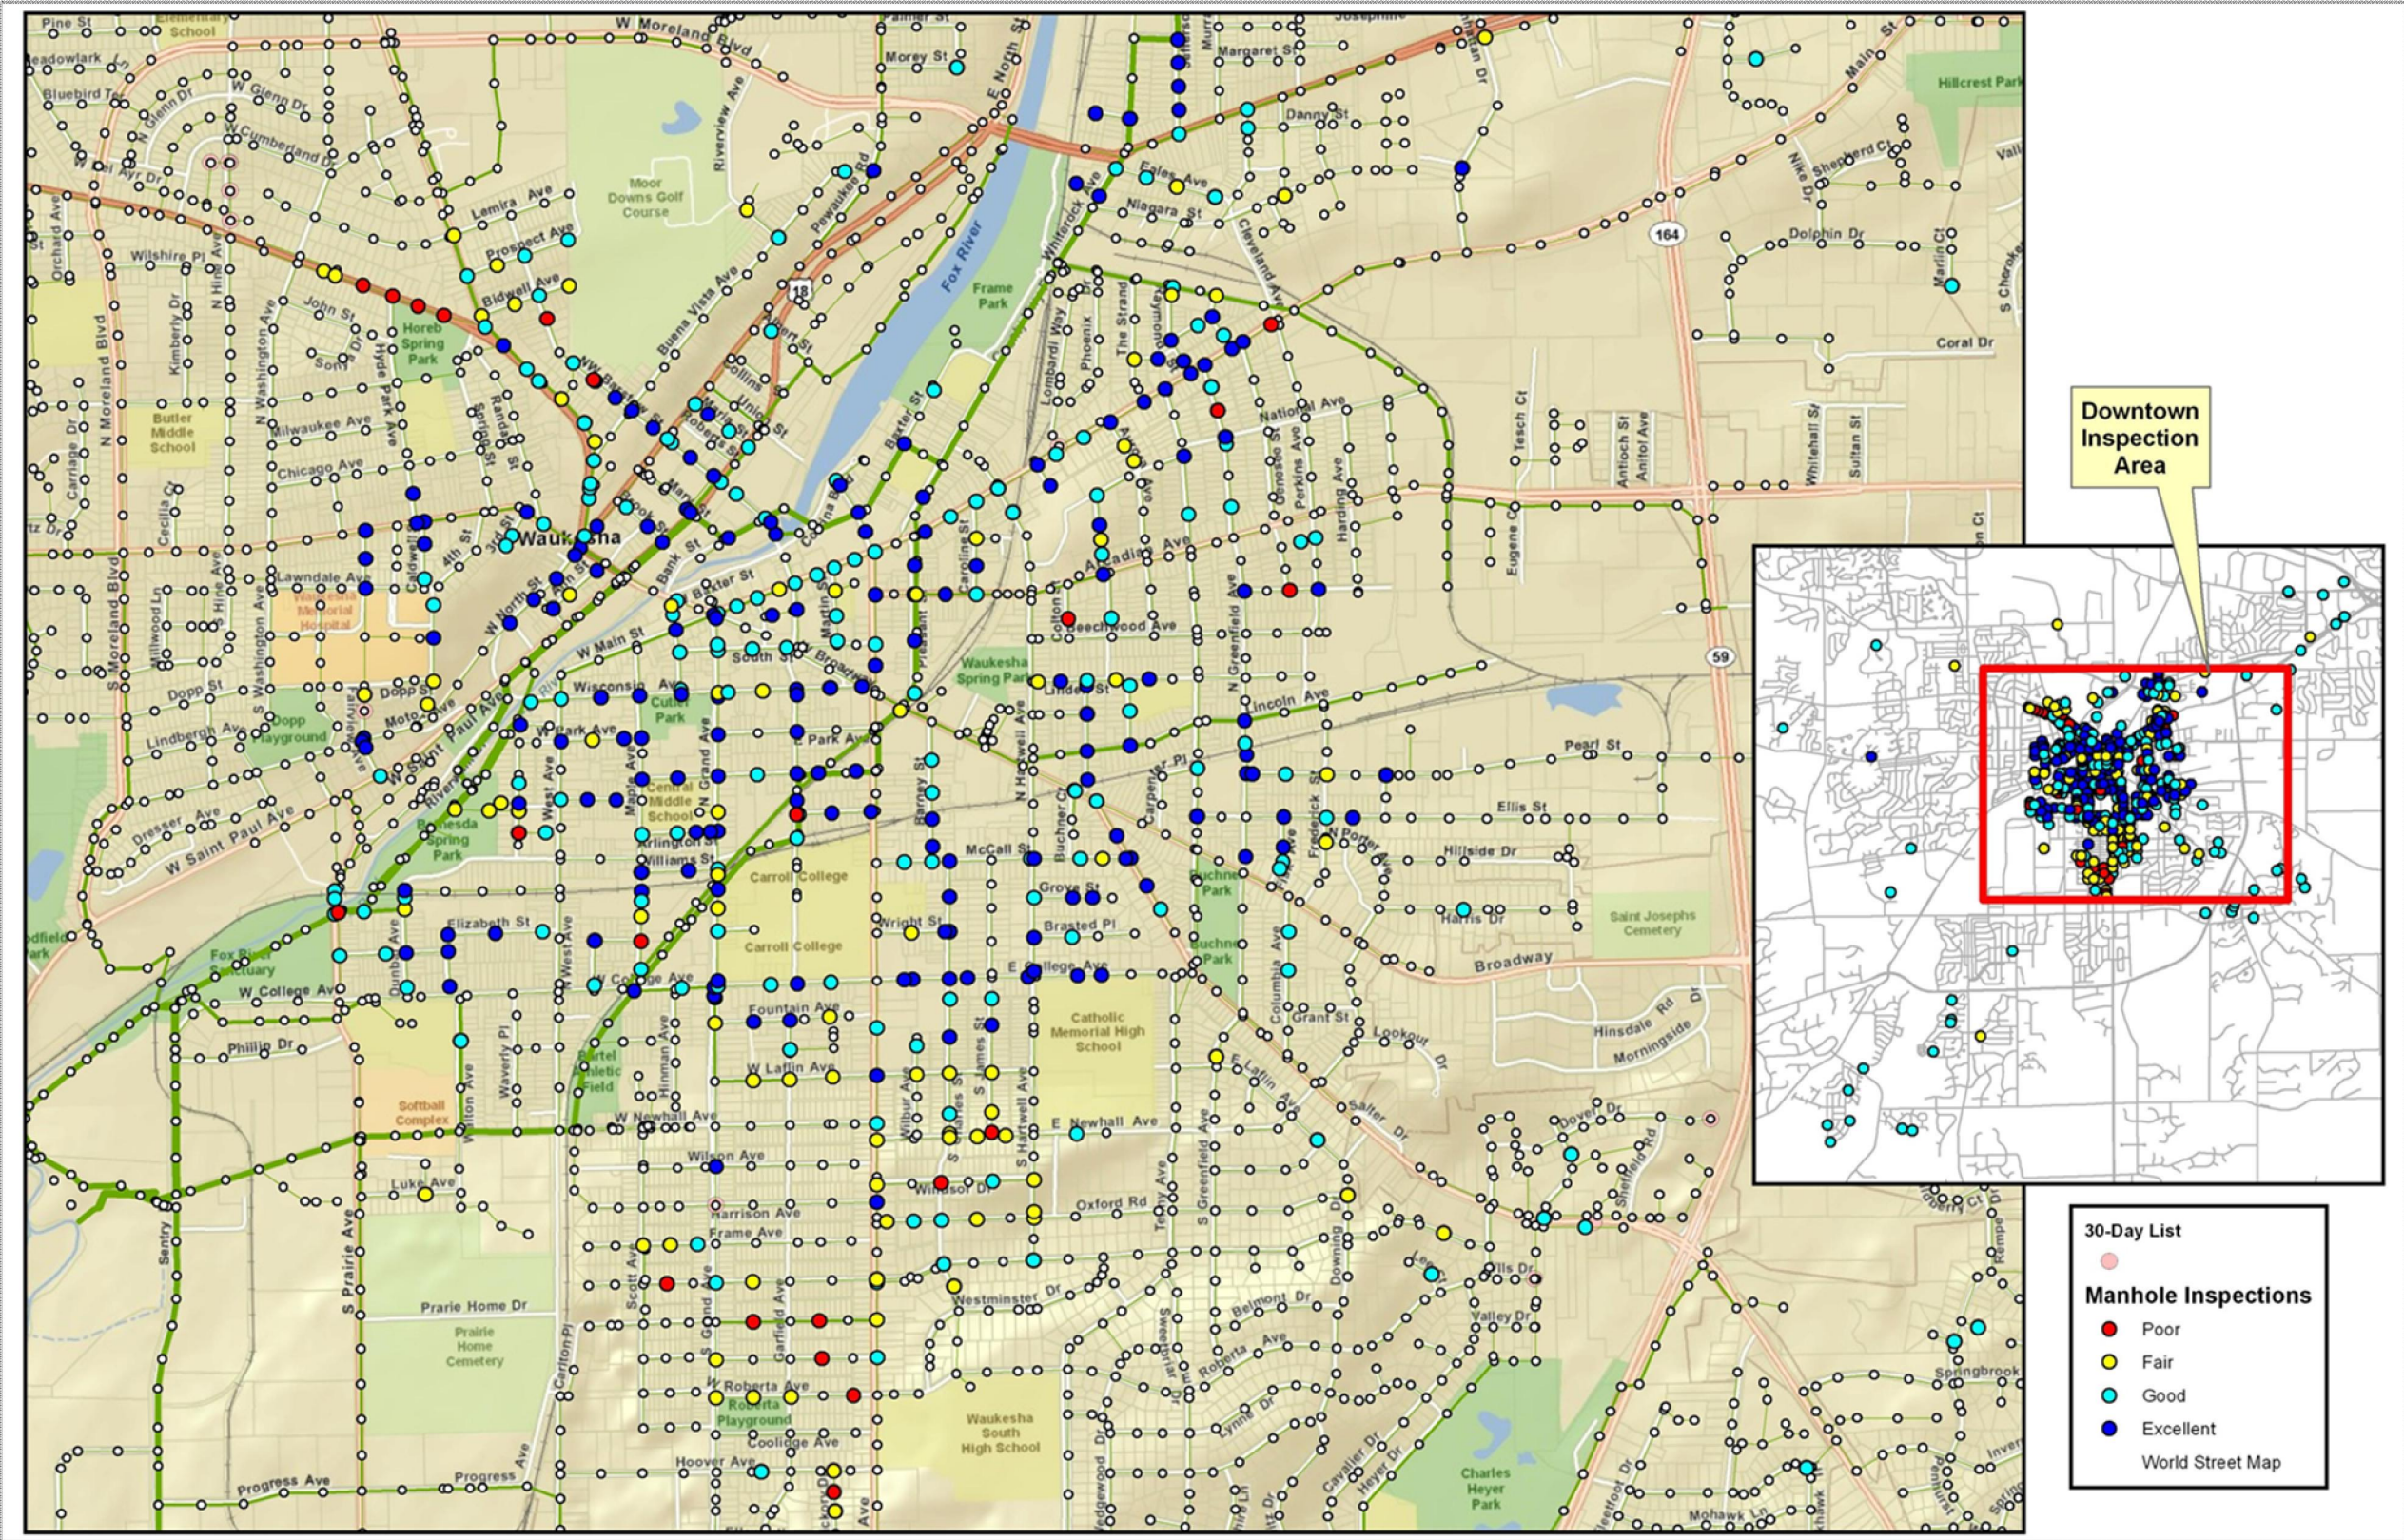
Figure 17 – Location and Condition of Inspected Manholes

Donohue used this database to develop a rating system, categorizing the manholes as being in excellent, good, fair, or poor condition. Of the 477 manholes inspected, 368 (77%) were found to be in good to excellent condition, as shown in Figure 16. The locations of these manholes are shown in Figure 17. These ratings are based on a generic rating algorithm; therefore, Donohue evaluated the specific defects of each manhole in order to develop specific rehabilitation recommendations.

Rehabilitation and replacement recommendations were based on data received from manhole inspection data. This data was compiled into an Access database and cross-referenced with the 30-day cleaning list, street reconstruction projects, and manhole characteristics. To facilitate the review, an inspection form (Figure 18) was created to view the characteristics, defects, and pictures of each manhole. Reviewers populated the fields near the top and bottom of the form, recommending specific rehabilitation methods and priorities appropriate for the manhole condition information from the middle of the form.
